December 11, 2013

Reference: Final Inspection of Golf Cart Bridges for The Groves Golf & Country Club

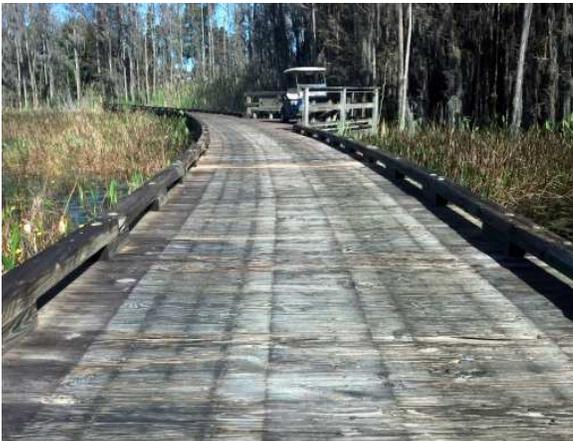
1. Only a fraction of the recommended deck planks and curbs identified as severely checked were replaced. (e.g. Approximately only 5 of the recommended 375 boards on bridge No. 6 were replaced) Major portions of the deck planks that we believe are a hazard remain in place.
2. Bridges 4, 5 and 6, which we listed as high priority for deck plank replacement, were given low priority when installing new deck planks.
3. None of the new deck planks and curbs has been sealed to protect them from the sun/moisture cycle, which is what necessitated the replacement of the original planks.
4. The wear deck planks on bridge No. 6 were removed as recommended.

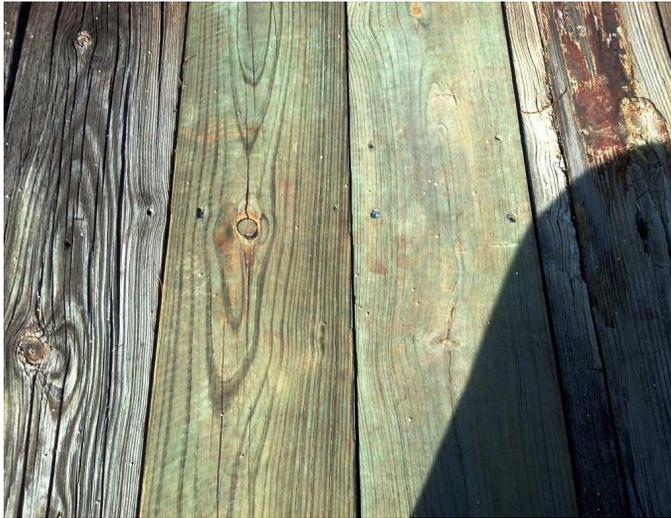
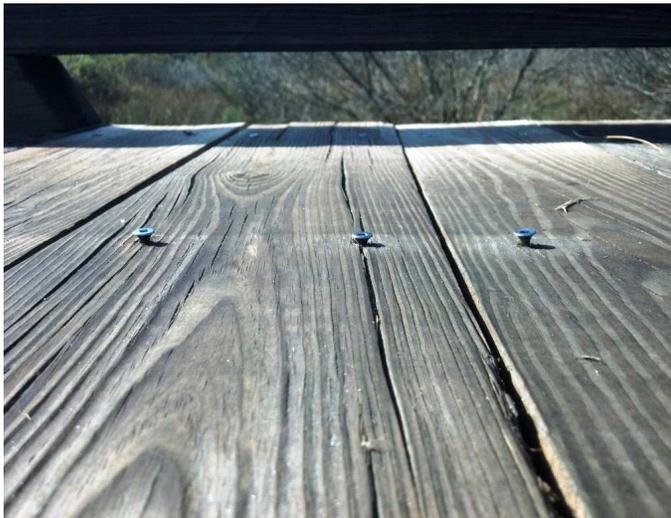
5. Based on Rich Unger's verbal assurance, 4.5" long screws were used to fasten the new 3" thick deck planks. This allows the proper embedment length necessary of 1.5" into the supporting member below. The majority of the screws were installed correctly; however, some screws were left too high, causing a tripping hazard, and others were counter sunk, creating a pocket for water to pond. This may cause the screws to rust.

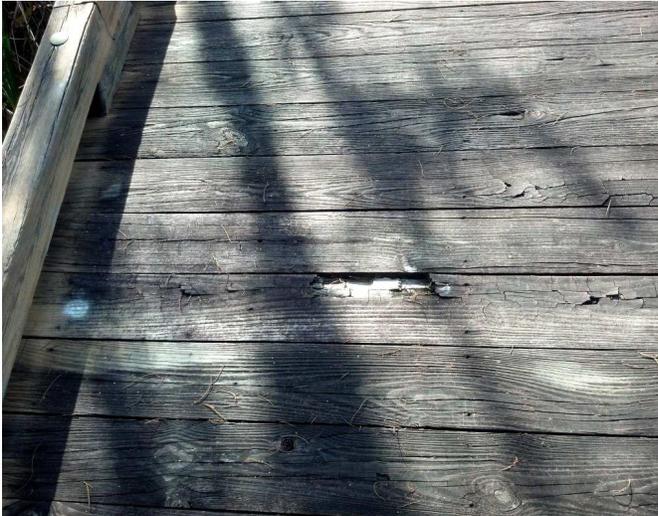
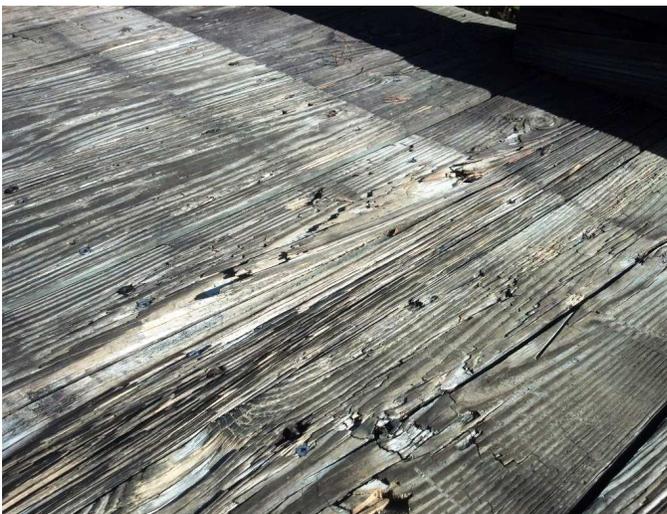
7. Our recommendation of pressure cleaning, sanding and grinding, and application of an oil based preservative sealant on the exposed surfaces was not done. Lack of an on-going maintenance program (i.e. cleaning and sealing every 2 to 3 years) has led to the current condition of the deck surface which is caused by the cyclical exposure to moisture and ultra violet rays from the sun.
8. Overall, the condition of the deck planks has worsened since our last inspection 1 year ago, with major checks and splits in the deck visible. We strongly encourage the Board to revisit our report dated 12/14/12, and obtain price quotes from a qualified timber bridge restoration contractor for each of the 4 alternatives we provide.
